REPORT ON THE JANUARY 17, 1994 NORTHRIGDE EARTHQUAKE SEISMOLOGICAL AND ENGINEERING ASPECTS

Takeshi Mikumo Carlos Gutiérrez Kenji Kikuchi Sergio M. Alcocer Tomás A. Sánchez

Julio - 1994, No. 8

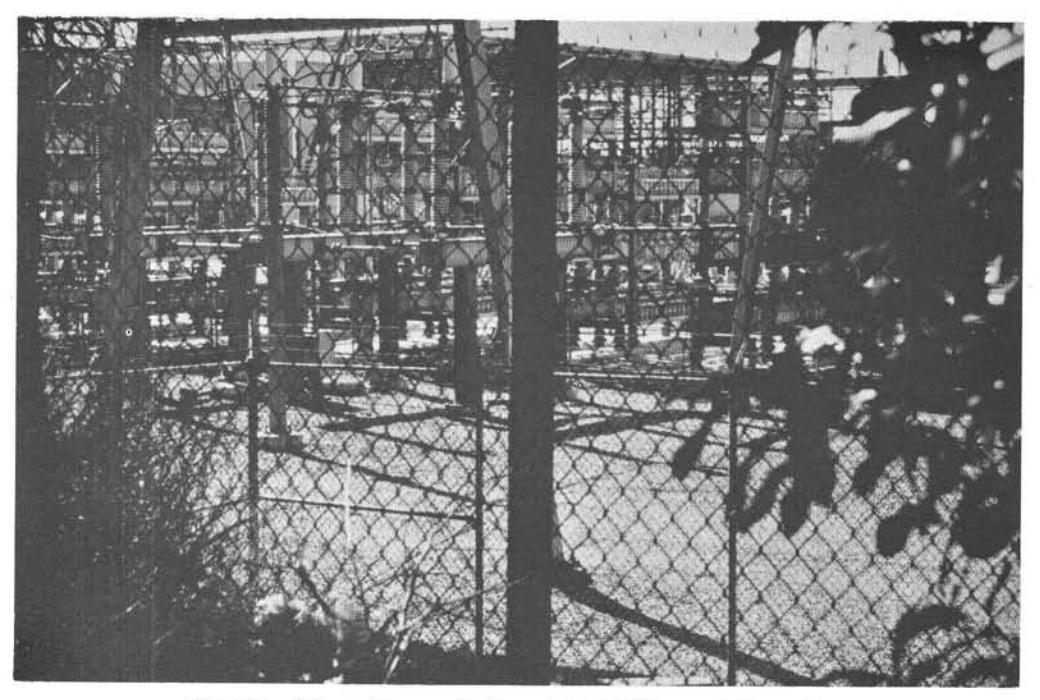
After the earthquake, 150,000 customers had no service; but by January 21 only 2,300 customers remained without electricity. Damage was concentrated in one 500kV substation and in two 230kV substations from the Sylmar Power Station (Fig. 22), NW to the epicenter. This power station was also damaged in the 1971 San Fernando earthquake. At that time, this damage showed the need to fix the electrical equipment with adequate anchorages. In fact, at that time, because of anchorage deficiencies, several transformers and other components were turned over and failed causing severe damage. As a result, components and equipment were replaced by new ones designed to resist a 0.5g acceleration level and also fixed with adequate anchorages. Nevertheless, during the Northridge earthquake, instruments in one of the substations registered ground accelerations of 0.6g. Several electric components were again severely damaged.

Fig. 22 Sylmar Power Station at the NW part of the epicenter.

The ceramic components are one of the most vulnerable parts to earthquakes actions, particularly in 220kV equipments or bigger. While the development of high-strength ceramic or of isolators with a more ductile materials is done, isolation systems must be designed for low stress levels. Other option is to replace the cantilever supports for the isolators with multiple supports. The use of dampers has shown to be adequate.

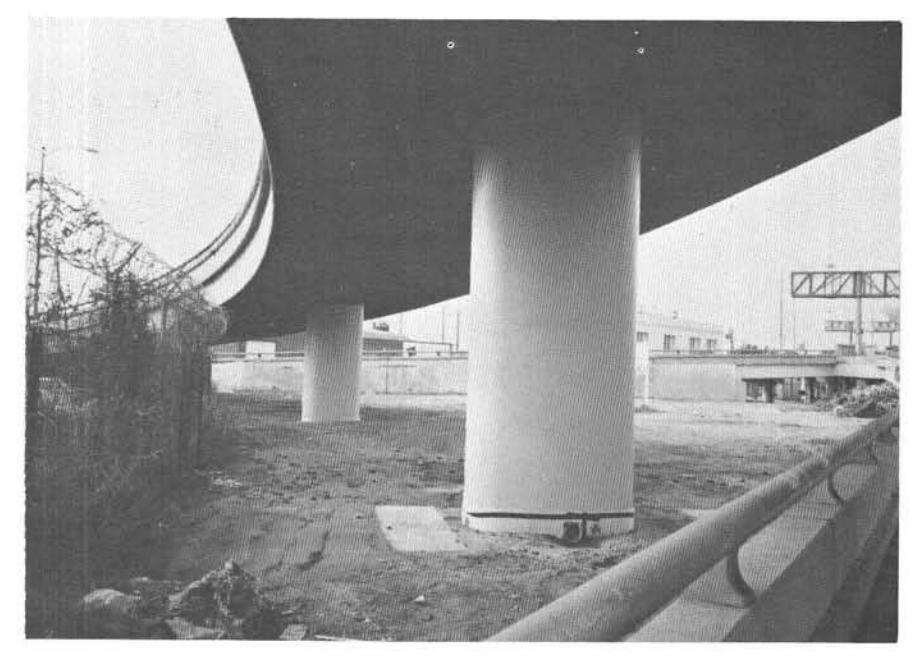
Fig. 23 Steel jacketing of bridge columns behaved well.

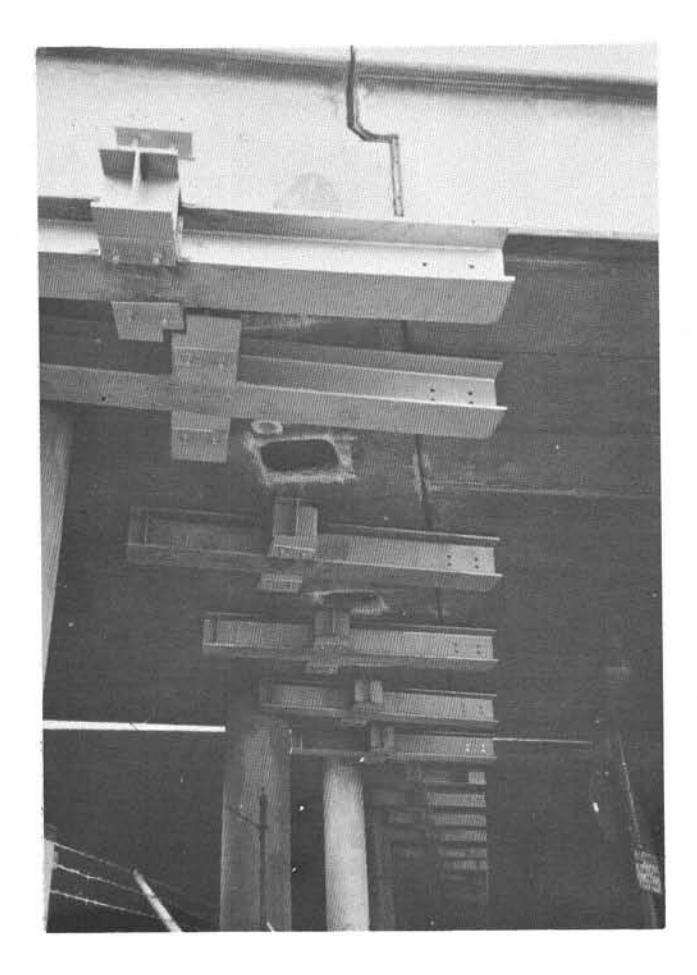
Fig. 24 Rehabilitation of seats by means of increasing the support length with steel members.

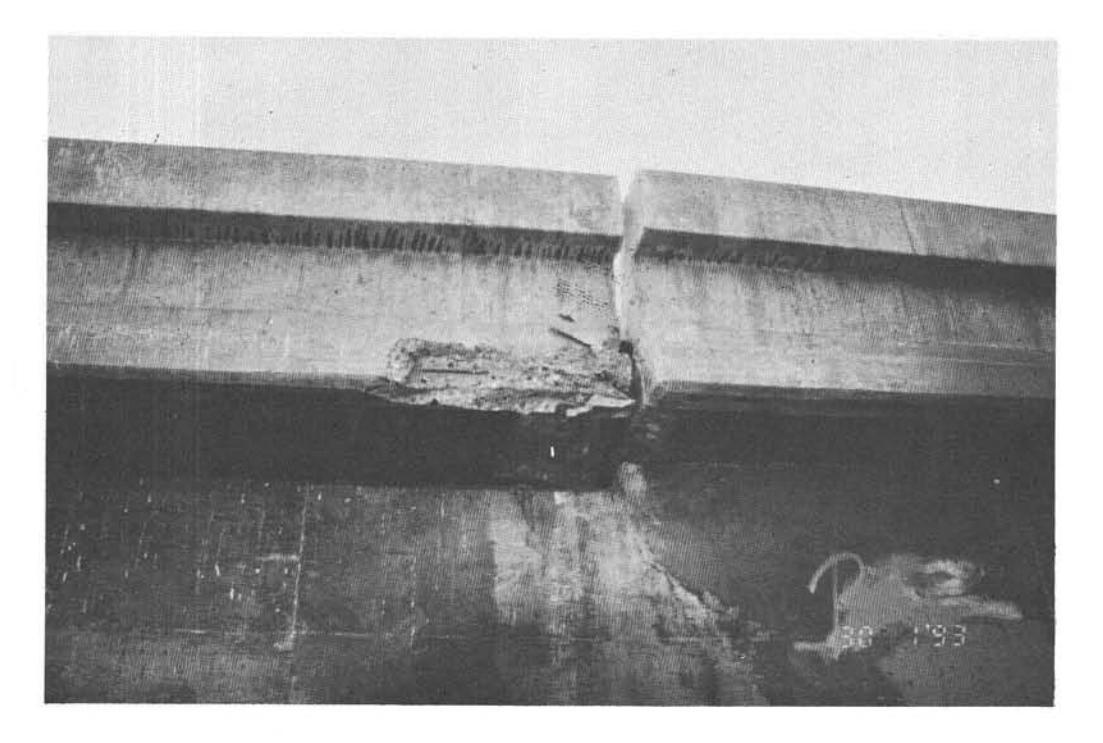
Fig. 25 Spalling of concrete cover in the parapet joint between two precast bridges.

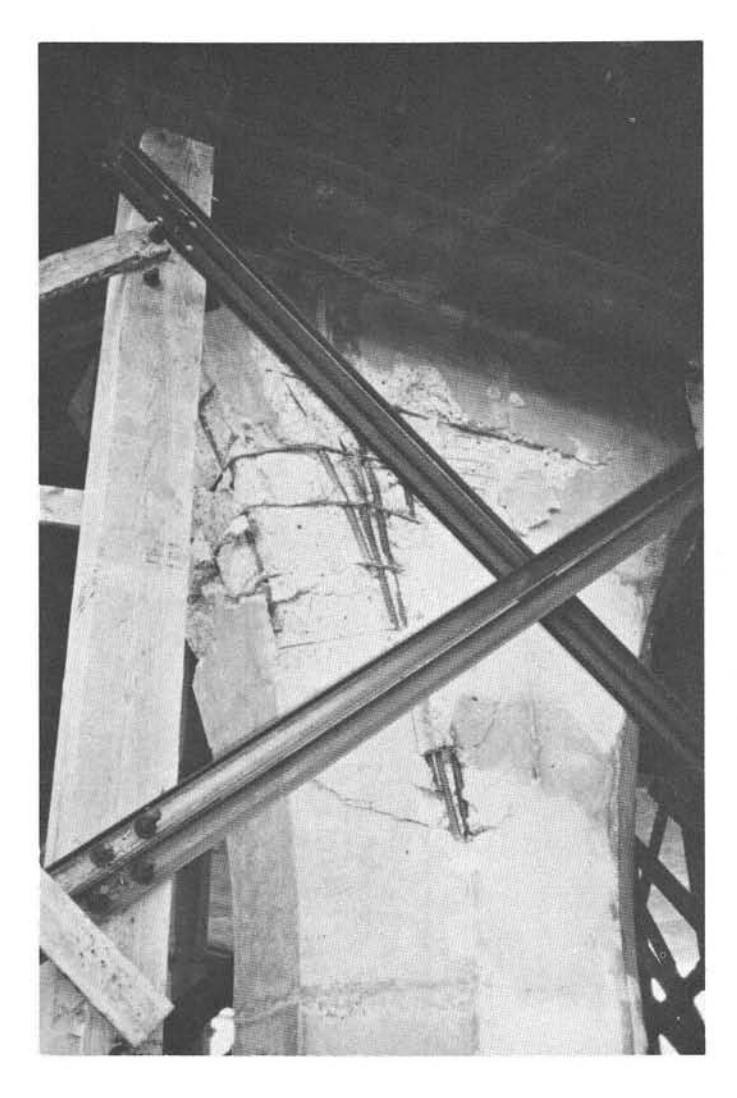
The most common failure mode was brittle shear or semiductile shear (flexural hinging first and shear failure after). For example, in I-10 near La Cienega, concrete columns showed an inclined failure plane and concrete crushing in the zone where longitudinal reinforcement buckled (Fig. 29). Possibly, high horizontal accelerations caused the column to fail in shear while the vertical acceleration added to the deterioration. According to Caltrans, the I-10 bridges had been identified as highly vulnerable structures and there were to be rehabilitated soon.

Fig. 26 Shear compression failure and rebar buckling in bridge columns.

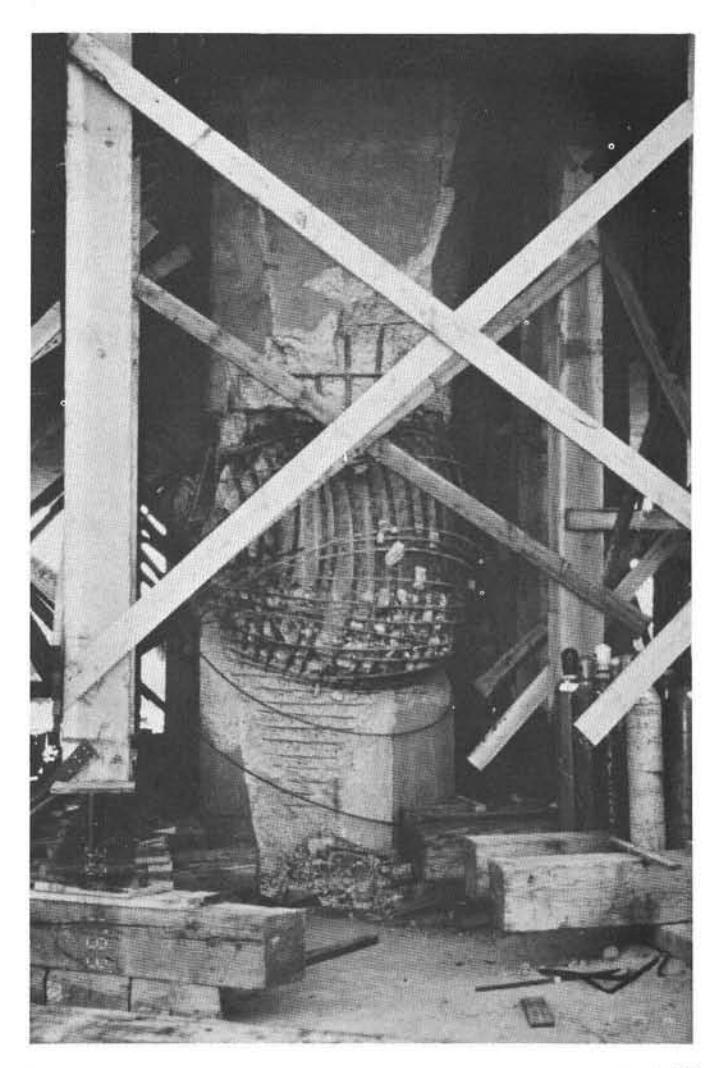
Fig. 27 Shear compression failure and rebar buckling in bridge columns.

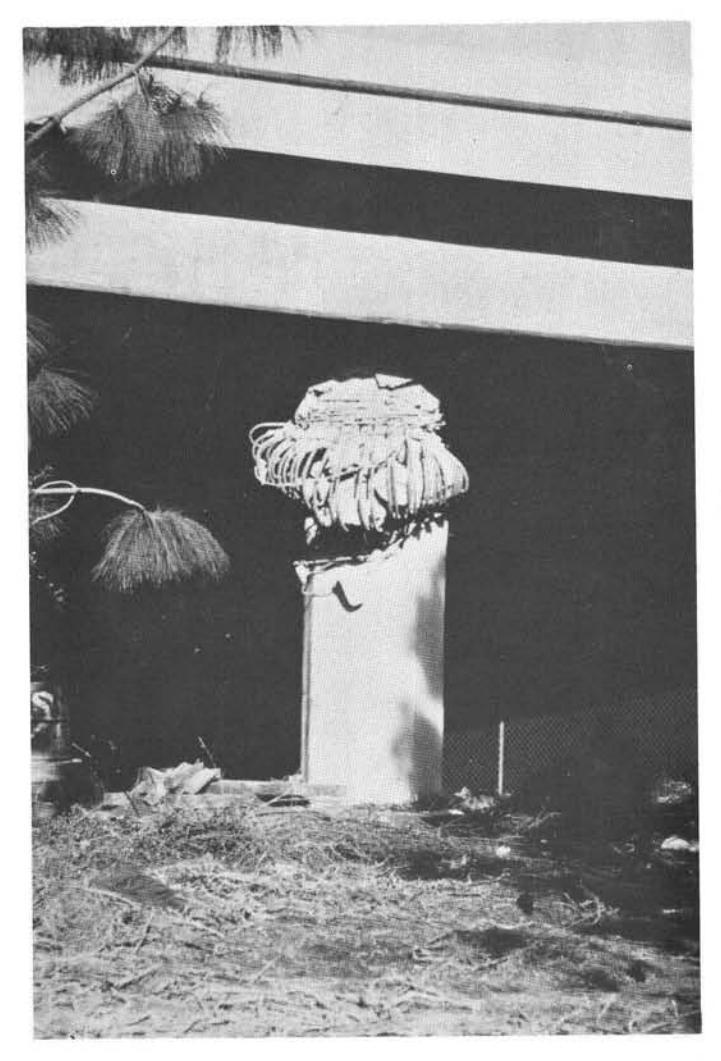
Almost the entire 1,000 km of freeways in Los Angeles area resisted the 1994 earthquake without considerable damages. As a reference, three million cars move everyday in this area. In most cases, rehabilitated structures (steel jacketing of columns (Fig. 23)) by Caltrans since the Loma Prieta earthquake (1989) behaved well (Fig. 24). Nevertheless, damage in 10 bridges was observed (Figs. 25 to 27). Main damage occurred in Interstate Highway 5 (at the junction with Roads 118 and 210), in Interstate Highway 405 and I-10; and in Roads 101 and 118. Three types of failures were observed: a) Column failure due to shear-compression (Figs. 26 and 27); b) Column flexural hinging (Fig. 28); and c) Beams fell down because they lost their seats.

Fig. 28 Column flexural hinging.

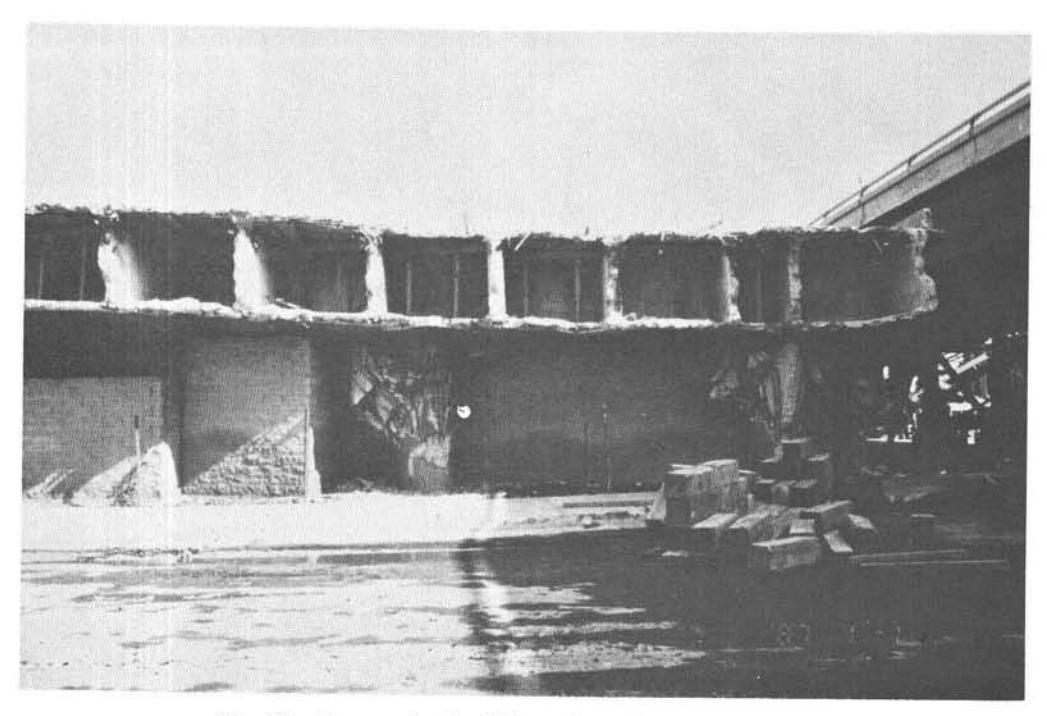
Fig. 29 Impressive buckling of steel bars and concrete crushing along the height.

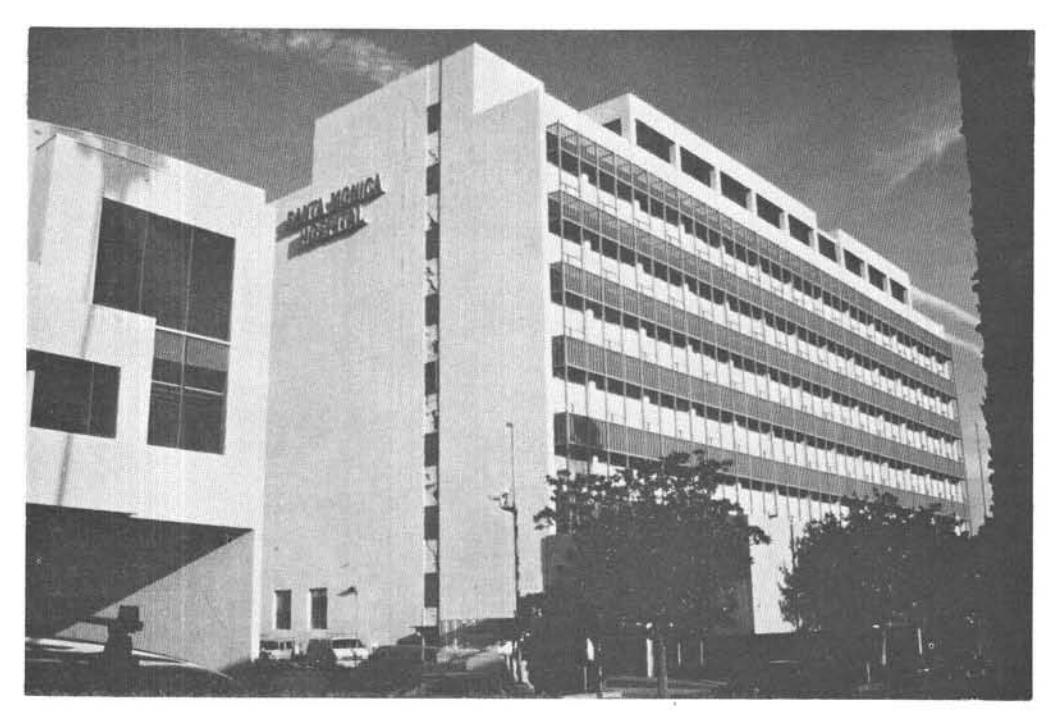
One of the damaged hospitals was the Santa Monica Hospital which is a R/C building with concrete structural walls perpendicular to the street, and with frames (beams and columns) parallel to the street (Fig. 30). During the reconnaissance evaluation, the entrance to the building was restricted. Damage was concentrated in the concrete walls and coupling beams (Figs. 31 and 32). Diagonal cracks were observed in R/C walls, which are evidence of high lateral forces. Horizontal cracks were also noted and agree with the location of construction joints. The latter type of cracking occurs along inadequately prepared joints between two castings. Indeed, construction joints must be carefully prepared removing the dust, slag or any other material which can impair bond between the old and new concrete. Construction joints must be roughened to increase the coefficient of friction; vertical rebars must pass through the joint to prevent and control possible cracking. In some cases, problems in construction joints can be explained by deficiencies in the detailing by the structural designer. Regarding coupling beams, tests carried out in laboratories and recent experiences during earthquakes have demonstrate that this type of beams can be detailed relatively easy (by placing diagonal reinforcement); beams designed accordingly have shown excellent response without severe damage. The coupling beams in this building were designed before the knowledge in this field was developed.

Fig. 30 General view of the Santa Monica Hospital.

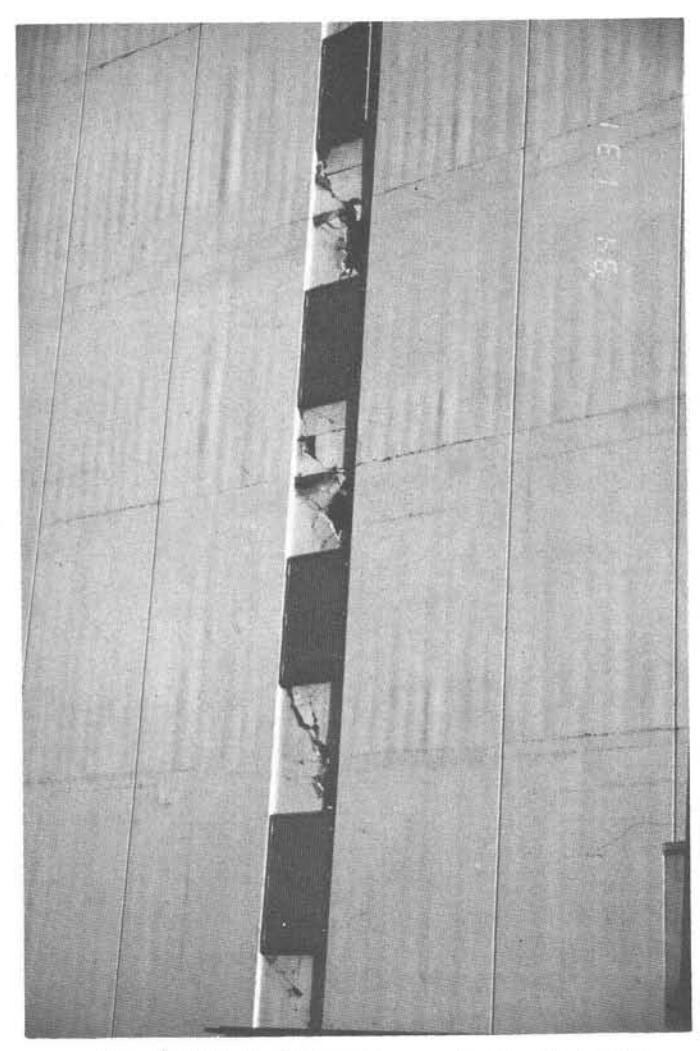
Fig. 31 Detail of shear damage in coupling beams.

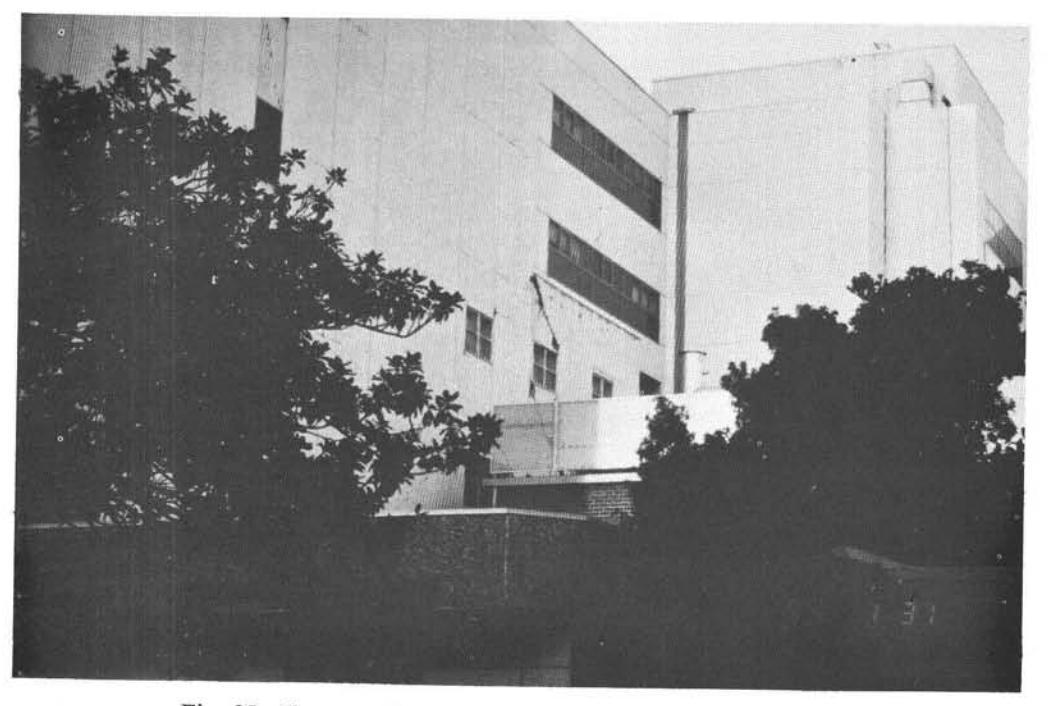
Fig. 32 Shear cracks in concrete walls near window openings.

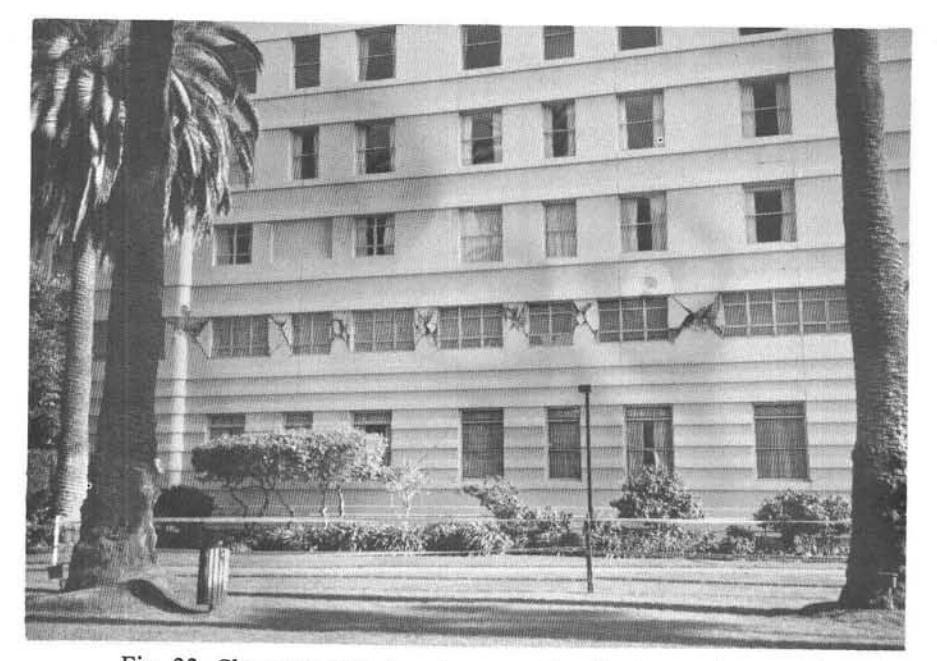
Other severely damaged structure was the St. John's Hospital located in Santa Monica. This is a 6-story R/C building with an appendix; possibly, the structure was built 40 years ago. Only the second story at the north facade suffered damage. Columns and short walls showed large diagonal cracks. Damaged was caused by a drastic change in strength and stiffness in this story with respect to others (Fig. 33).

Fig. 33 Shear cracking in columns and wall piers at the second floor in St. John's Hospital.

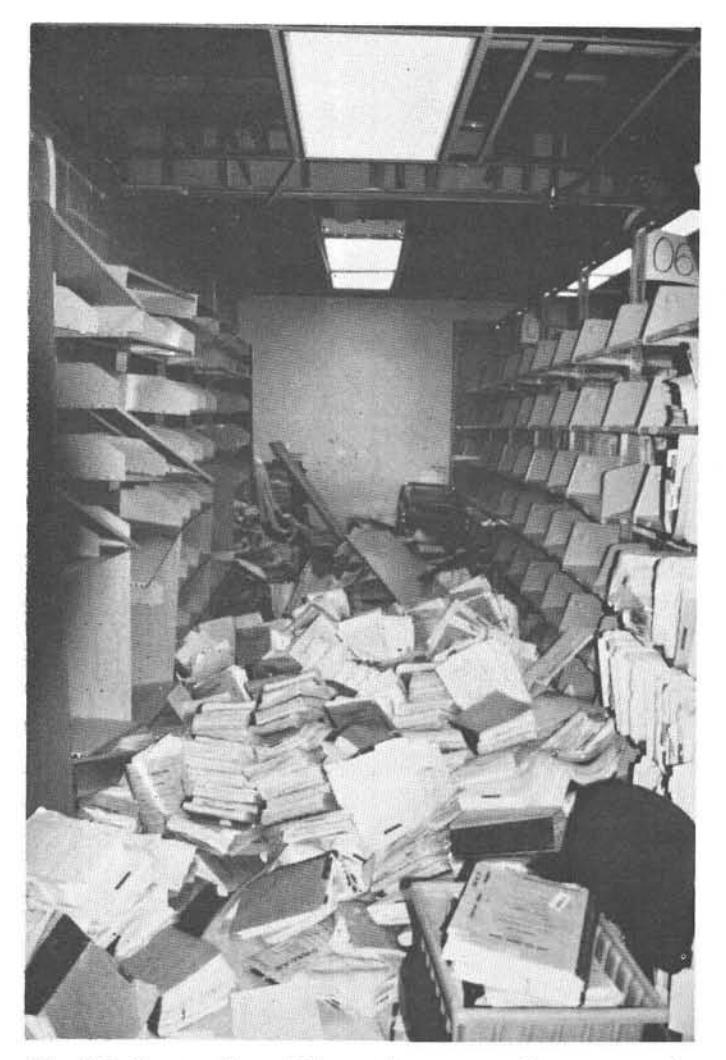
In the basement, office files with patient information overturned and some ceiling panels fell (Fig. 35). The upper most two stories were flooded due to a fracture of 2.5-cm diameter copper pipes. Also, seven fractures of the black iron pipe of the fire sprinkler system were identified. Although there was no structural damage, the water damage obligated the hospital evacuation.

Fig. 35 Overturning of files at basement and nonstructural damage of gypsum boards in roof.

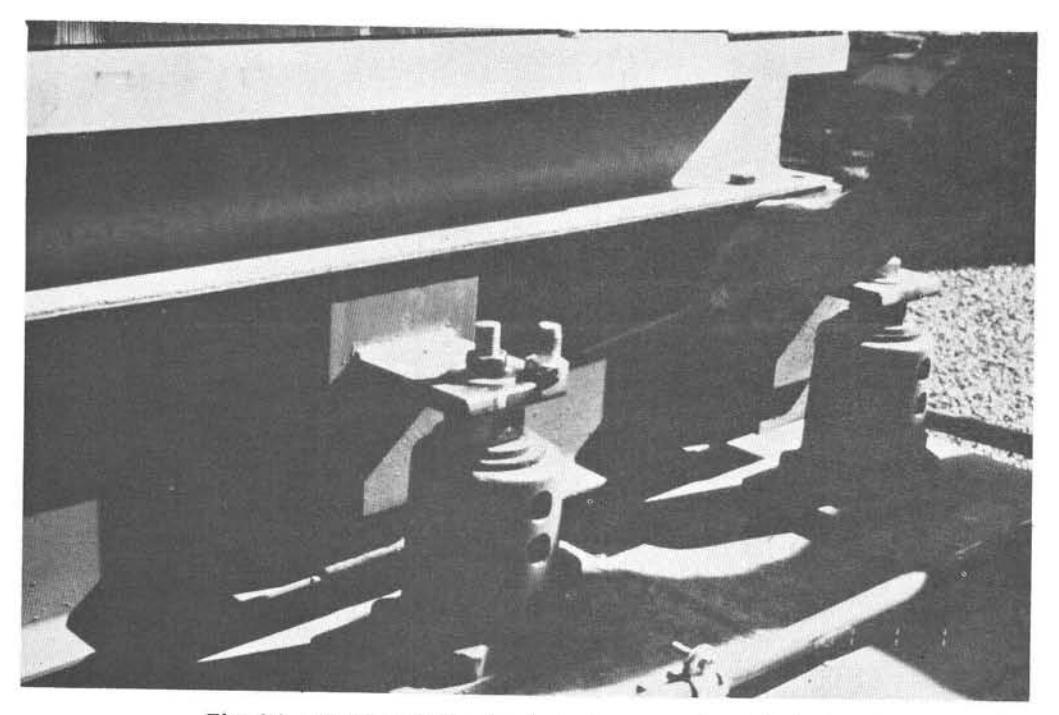
At the roof of the building, horizontal measured accelerations during the earthquake were 2.31g. A lamp detachment was observed. An air extractor equipment slipped due to an inadequate detail in the anchorage supports (Fig. 36). Anchor bolts were cut just above the nut. Shaking caused by the earthquake caused ripping of the bolt's thread thus allowing displacement of the equipment. Similar incipient failures in other equipments with the same anchoring detail were observed.

Fig. 36 The base plate of a steel structure allowed relative movements between slab and steel structure.

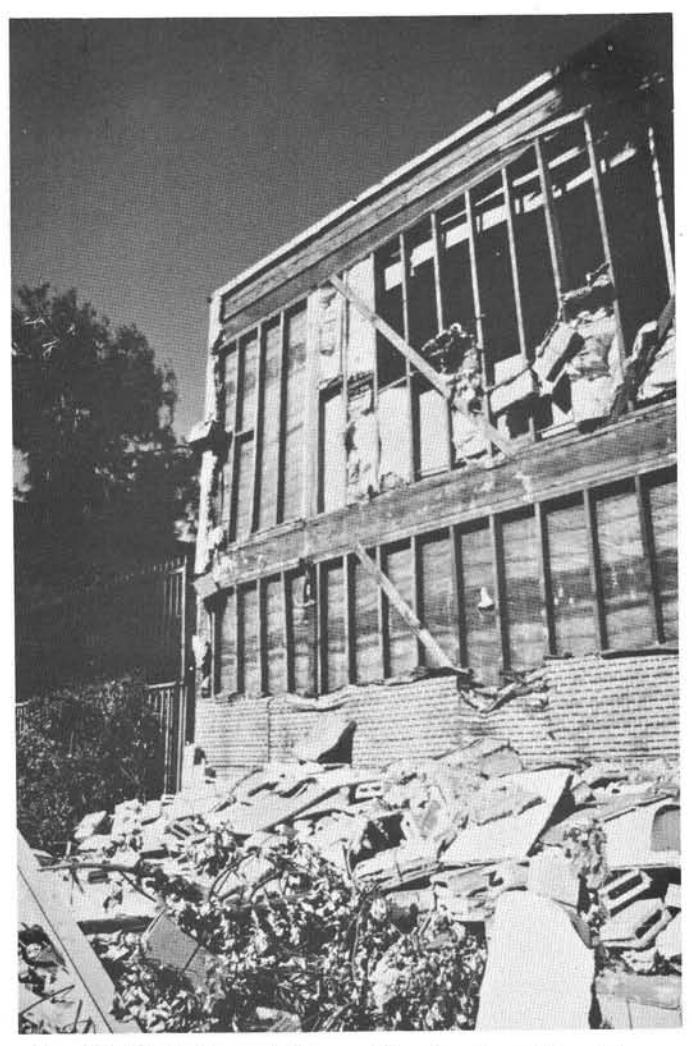
Fig. 38 Typical wood frames. The structure did not have structural walls.

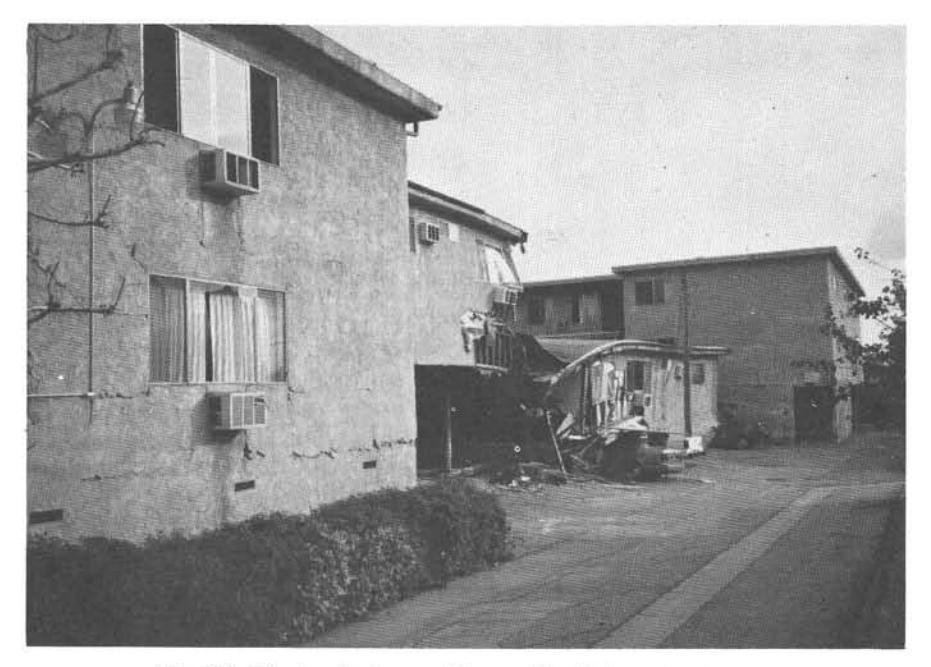
A characteristic of the damage pattern produced by the Northridge earthquake was that observed in multi-story timber frame structures. Several of them were lacking of wood structural walls. The collapse of the Northridge Meadow Apartments complex caused 16 fatalities. The structural characteristics of such type of buildings are similar: they are two- or three- story wood buildings with a ground soft story used as parking (Fig. 37). These apartment buildings were designed and constructed prior to the 1975 recommendations which required structural walls to be made with plywood sheets nailed to the frame (Fig. 38). During the earthquake, large lateral displacements were concentrated in the ground soft story (Fig. 39). In some instances, the structure was left standing but severely damaged; other buildings collapsed over the soft story. In other cases, failure was observed along the joints between the concrete masonry foundation (reinforced masonry) and the timber structure, and between upper wooden stories.

Fig. 39 First soft-story collapse of a timber structure.

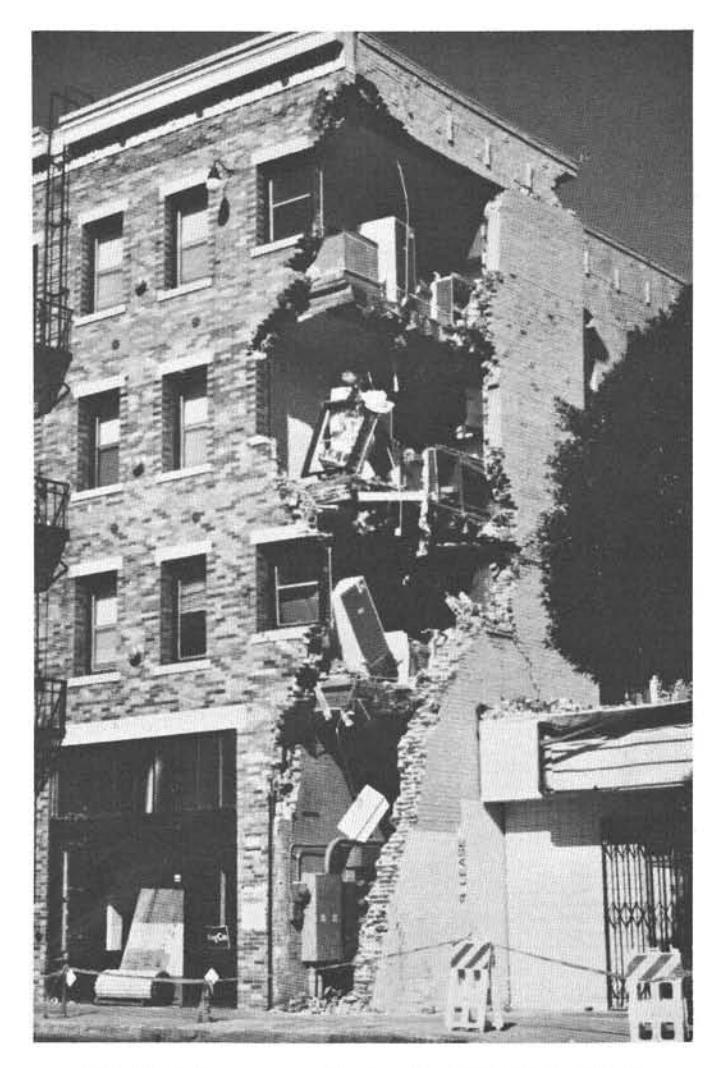
Main causes of damage and collapse of masonry structures in past quakes in different parts of the world have been: 1) lack of anchorage of roof or floor beams to walls; 2) inadequate detailing of beam-to-wall anchorages; 3) out-of-plane wall flexural failure; 4) diagonal cracking of the masonry panels; 5) excessive distortion of floor diaphragms; and 6) deficiencies in the shear transfer mechanism between floor diaphragms and walls. All these types of damage were observed in the area affected by the Northridge earthquake (Figs. 40 to 42).

Fig. 40 Masonry crushing and out-of-plane failure.

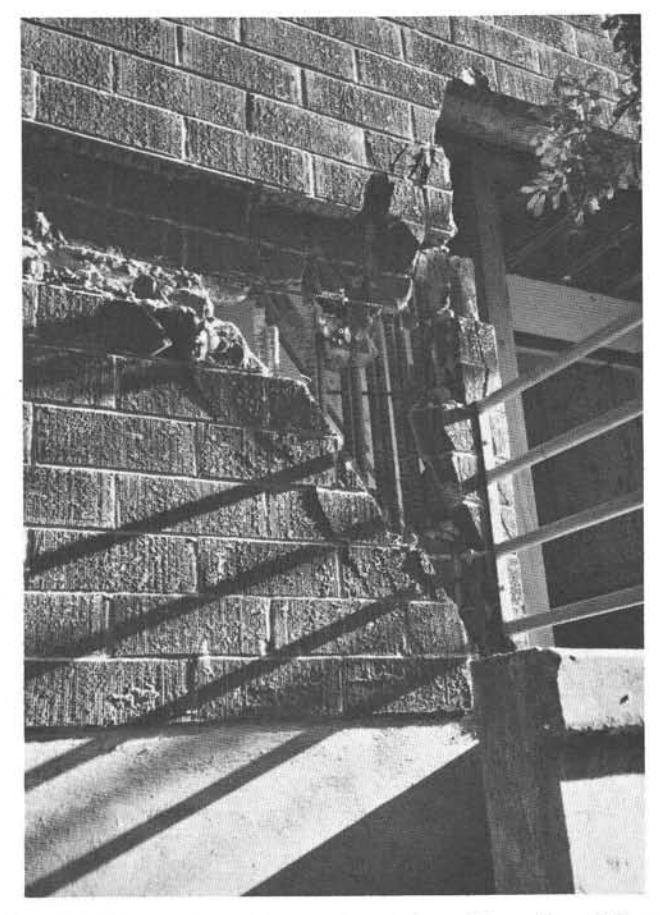
Fig. 41 Diagonal cracking and crushing of heavily reinforced masonry.

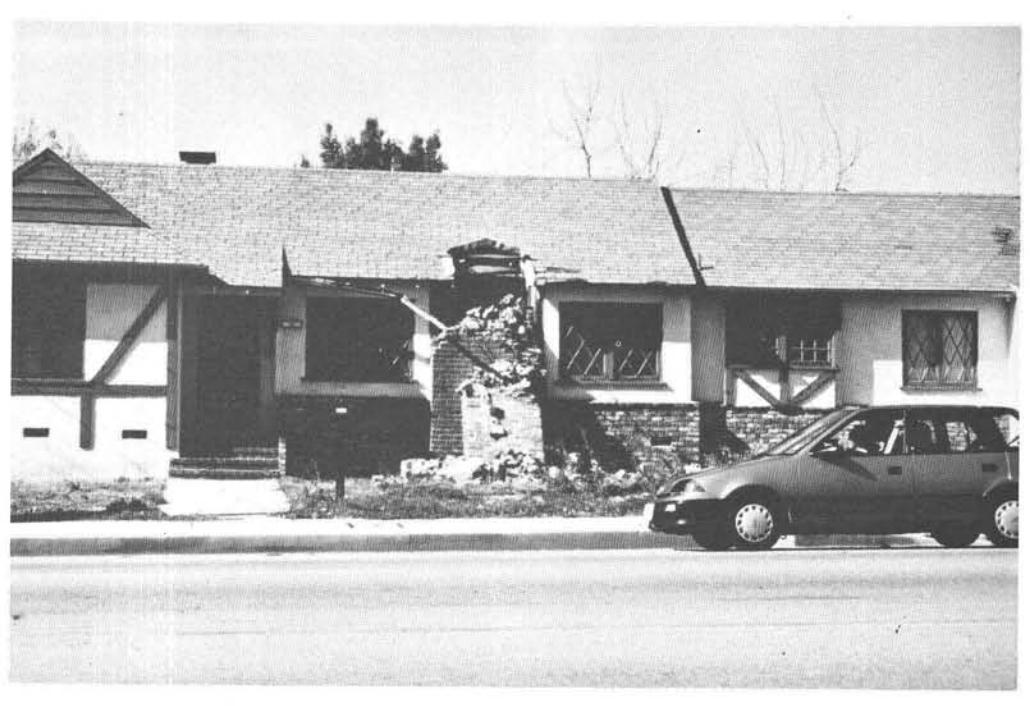
Fig. 42 Failure of a masonry chimney.

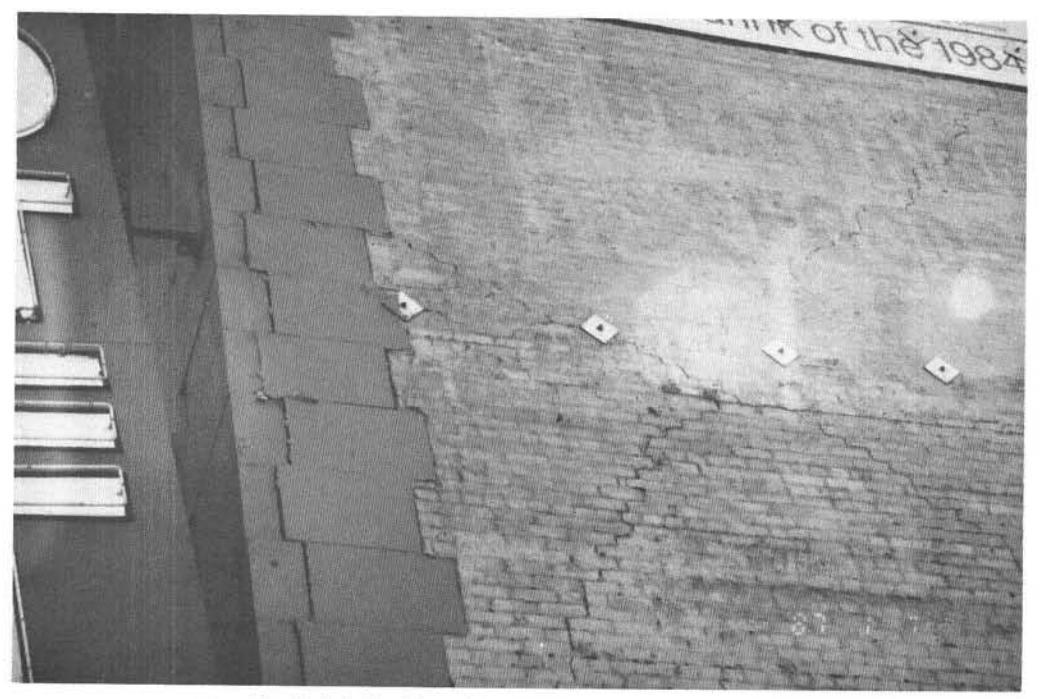
Fig. 43 Rehabilitation of an URM structure. Anchoring of slabs.

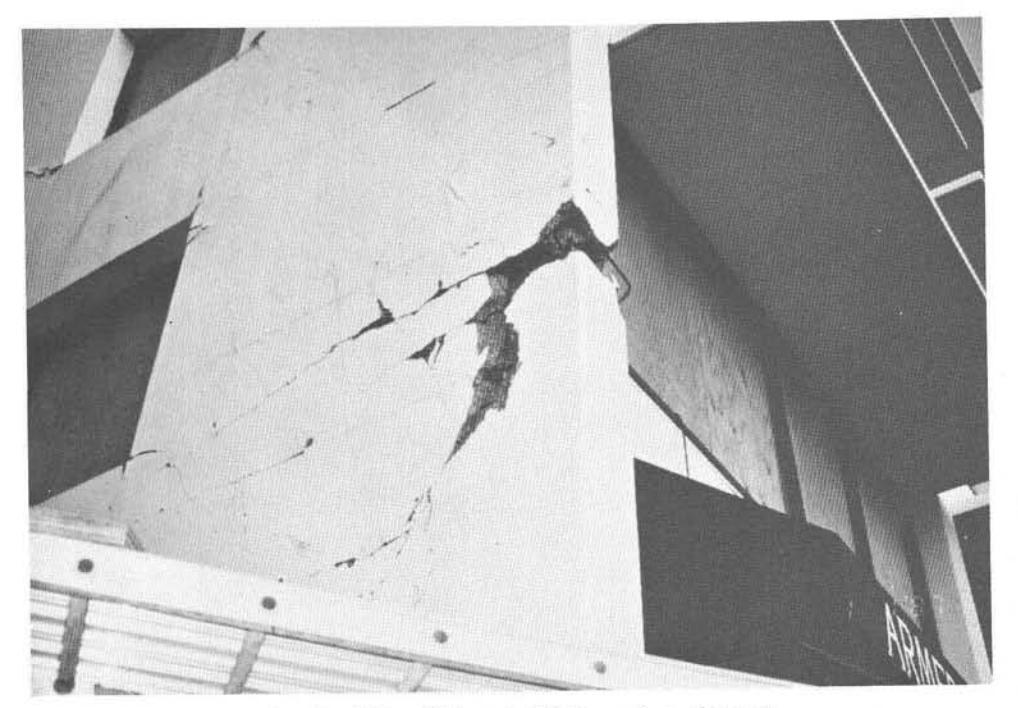
Fig. 44 Splice failure in RC boundary element.

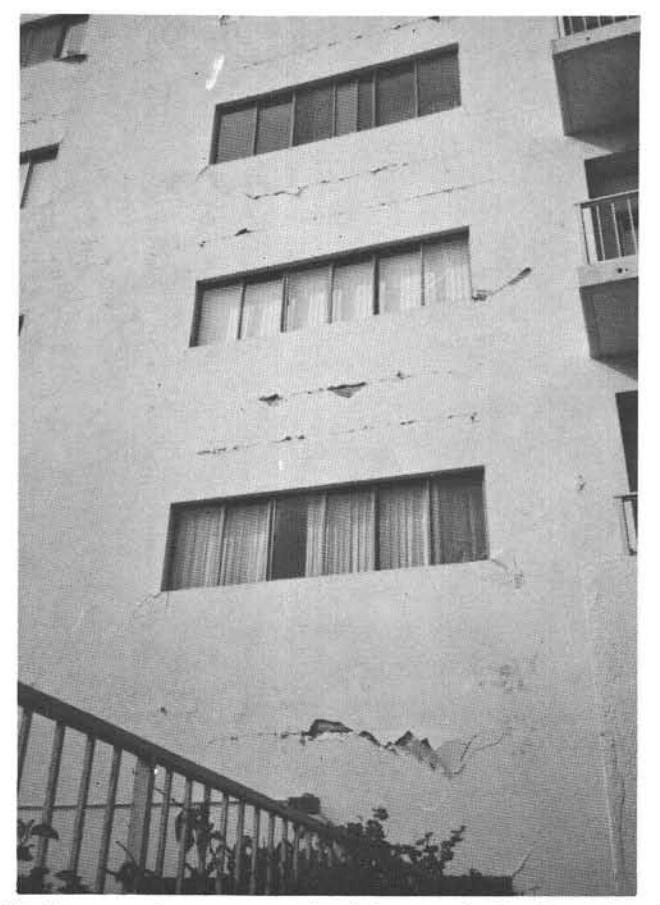
Fig. 45 Damage along construction joints, probably due to bond distress.

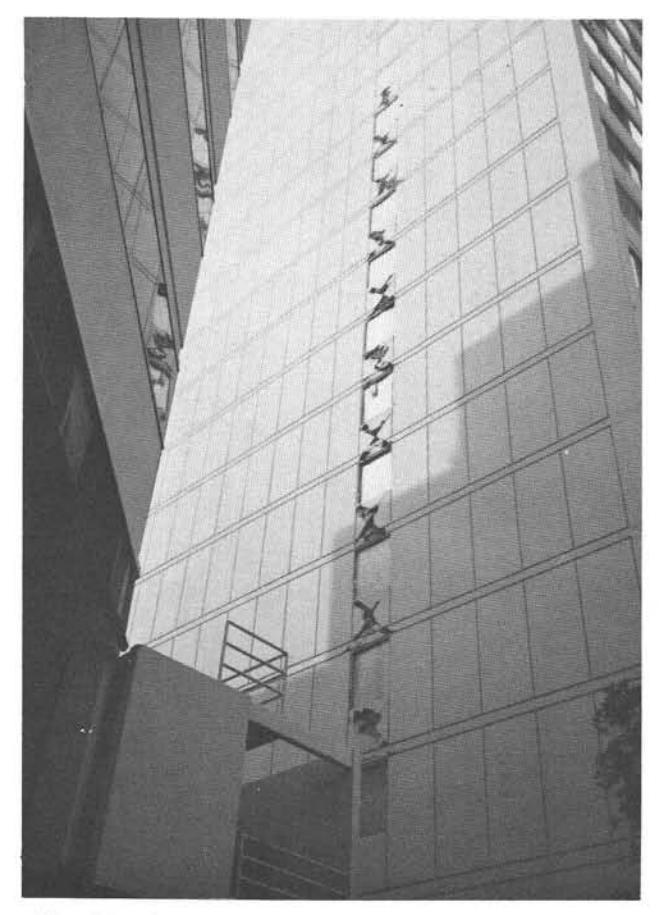
Fig. 46 Diagonal tension failure of coupling beams.

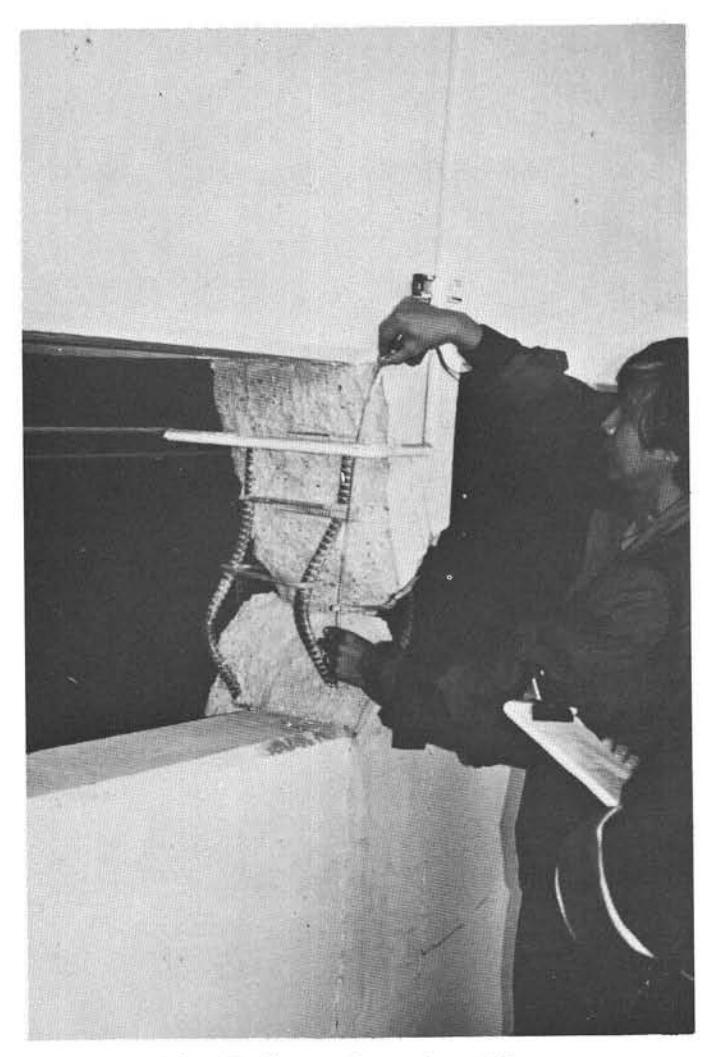
Observed failure modes in R/C structures included: 1) diagonal cracking and concrete crushing in poorly detailed beam-column joints; 2) shear failure at beam and column ends with improper detailing; 3) bond and anchorage failures of steel reinforcement (Figs. 44 and 45); 4) shear failure of coupling beams (Fig. 46); and 5) shear failure (brittle) in short ("captive") columns with height-to-width aspect ratios of 2.5 or less (Figs. 47 and 48).

Half-dozen of parking structures failed. Seemingly, failures were due to low redundancy and high flexibility of the lateral load resisting system. These buildings were designed to carry the gravity loads through interior columns which were not detailed to withstand cycling to large displacements (stirrup spacing was large, and in some cases, they were terminated in 90-deg. bends). In general, lateral load resisting system is placed around the perimeter of the building and is made of either ductile frames or ductile structural walls. Due to lateral displacement compatibility, assuming rigid diaphragms, interior columns were pushed to displacements that caused hinging at their ends. The combination of both non-ductile details and large horizontal and vertical accelerations explain the failure of the gravity load carrying system and the consequent structure collapse (Figs. 50 to 53). In some buildings, failure of short columns between ramps was recorded (Fig. 47).

Fig .47 Short column shear failure.

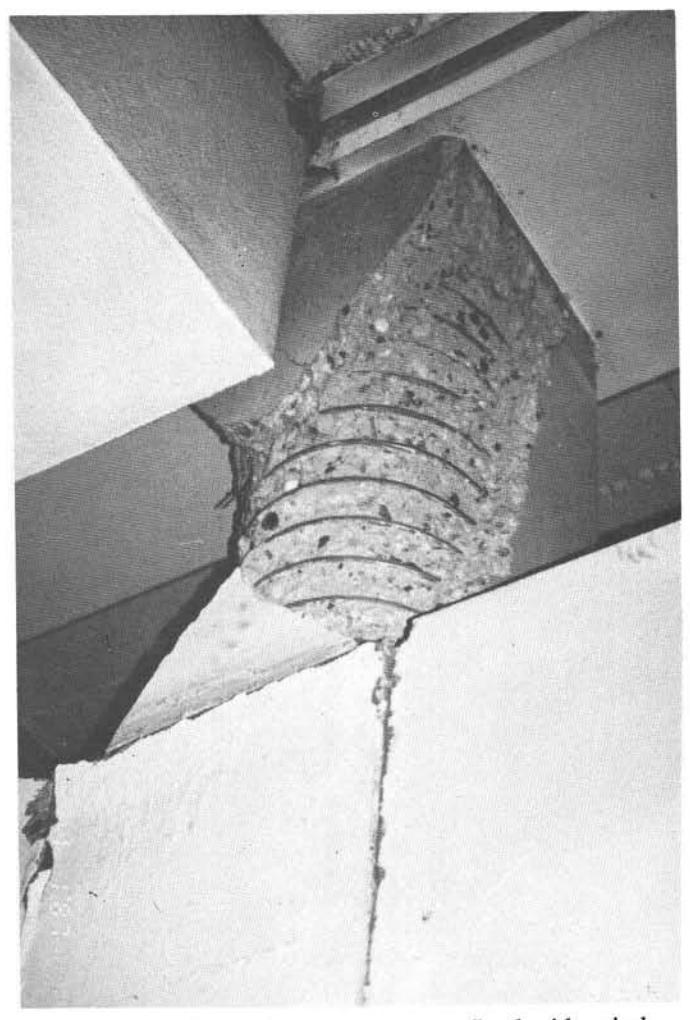
Fig. 48 Short column property confined with spiral reinforcement.

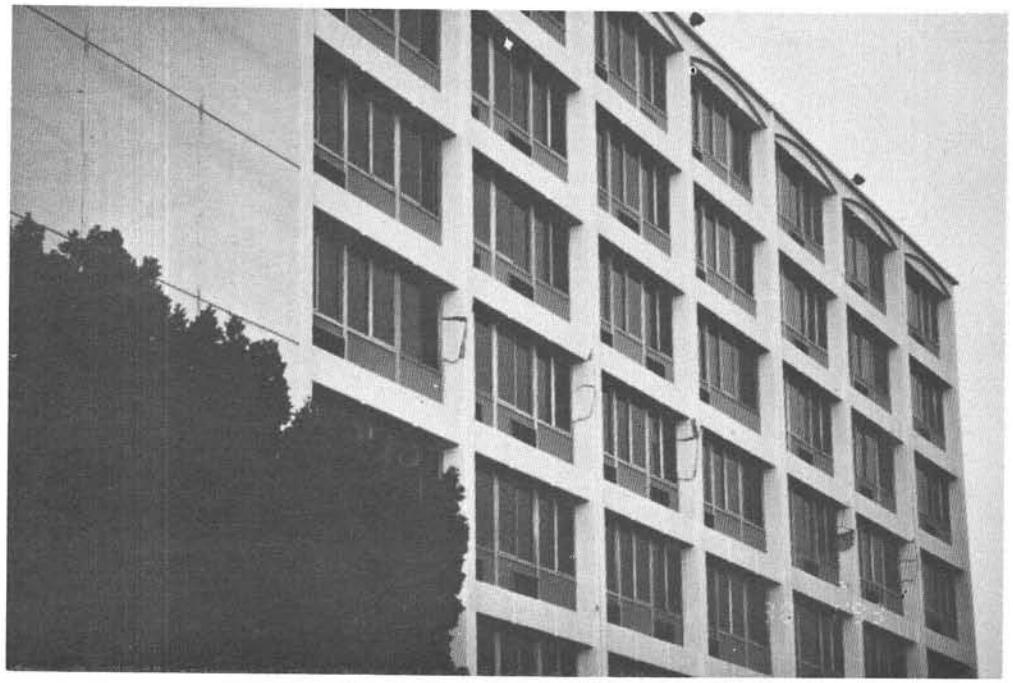
The instrumented building located closest to the epicenter (7 km) is a R/C frame built in the 60's and damaged in the 1971 event (Fig. 49). In the Northridge earthquake the structure was subjected to a base acceleration equal to 0.47 g; a 0.59 g maximum acceleration was recorded at the roof. Maximum recorded vertical acceleration was 0.30 g which occurred before the horizontal maximum (this was the case for all records). Although this building is not greatly damaged, its demolition is probable.

Fig. 49 Diagonal cracking of frame columns.

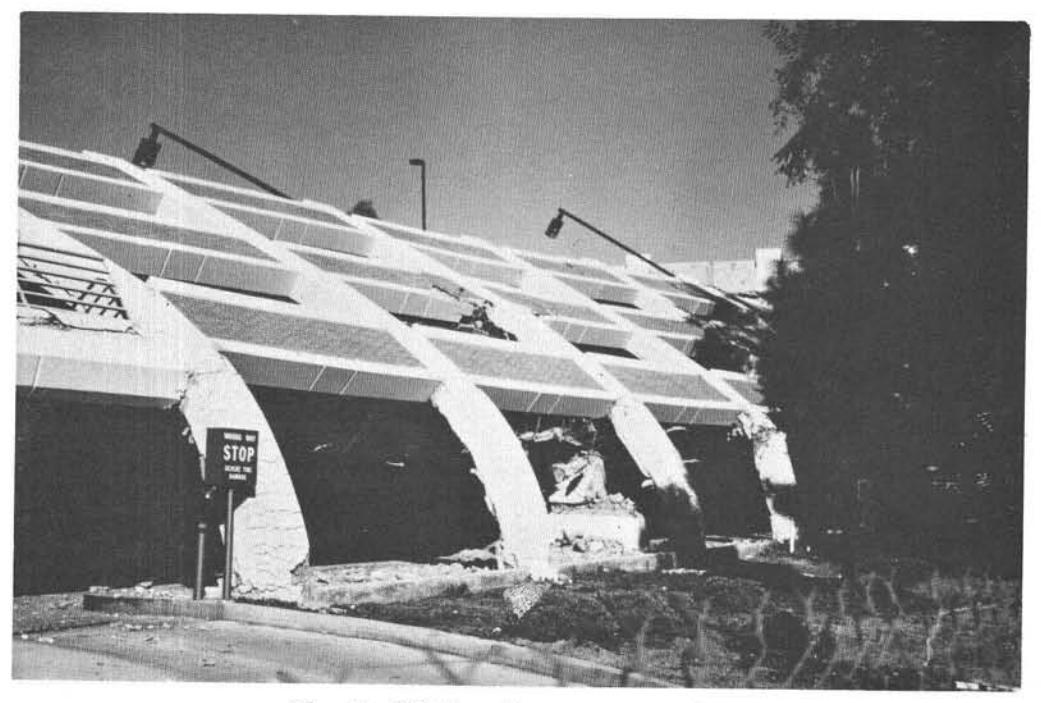
Fig. 50 CSUN parking structure collapse.

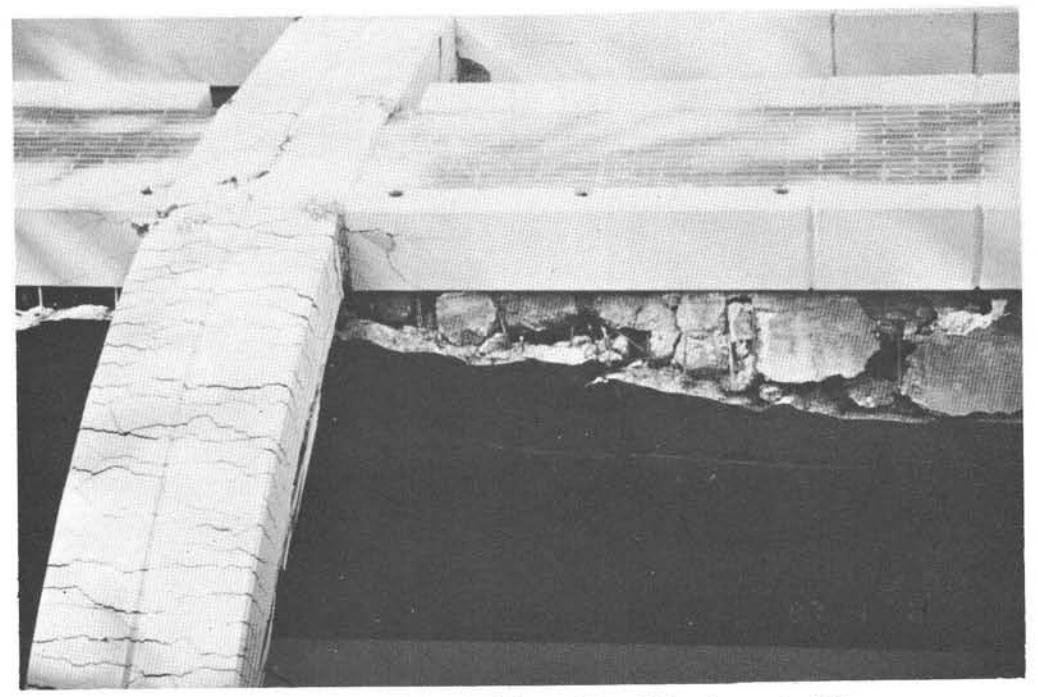
Fig. 51 CSUN parking building. Note RC column ductility
