REPORT ON THE JANUARY 17, 1994 NORTHRIGDE EARTHQUAKE SEISMOLOGICAL AND ENGINEERING ASPECTS

Takeshi Mikumo Carlos Gutiérrez Kenji Kikuchi Sergio M. Alcocer Tomás A. Sánchez

Julio - 1994, No. 8

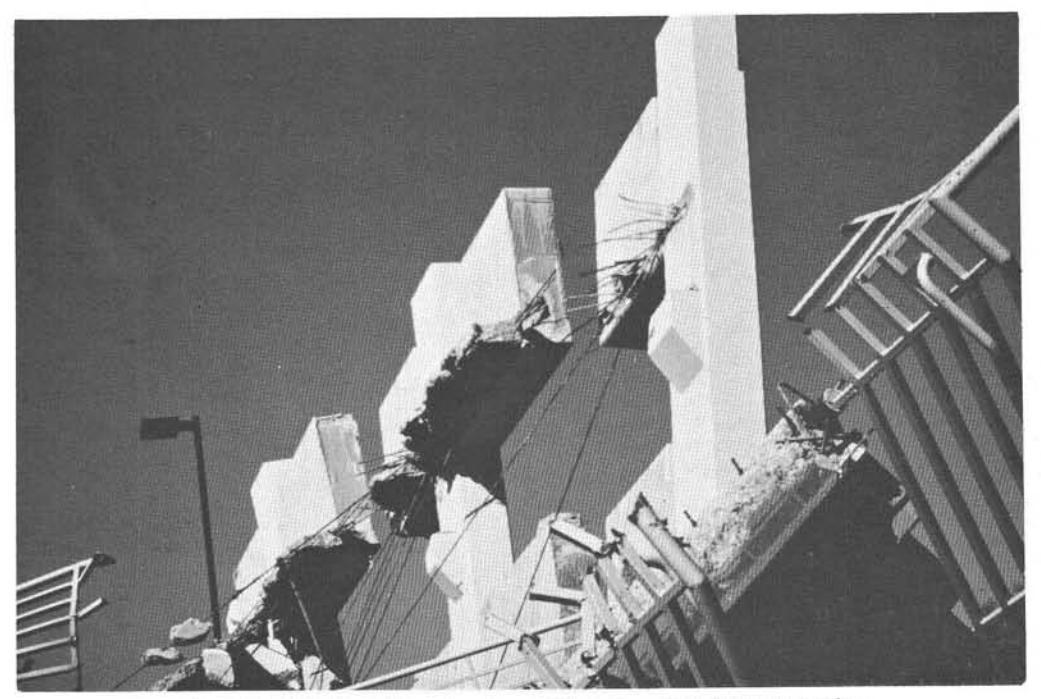
All damaged parking structures did not have integrity reinforcement.

Fig. 52 CSUN parking structure. Note brackets for supporting precast girders and minimal continuity reinforcement.
