REPORT ON THE JANUARY 17, 1994 NORTHRIGDE EARTHQUAKE SEISMOLOGICAL AND ENGINEERING ASPECTS

Takeshi Mikumo Carlos Gutiérrez Kenji Kikuchi Sergio M. Alcocer Tomás A. Sánchez

Julio - 1994, No. 8

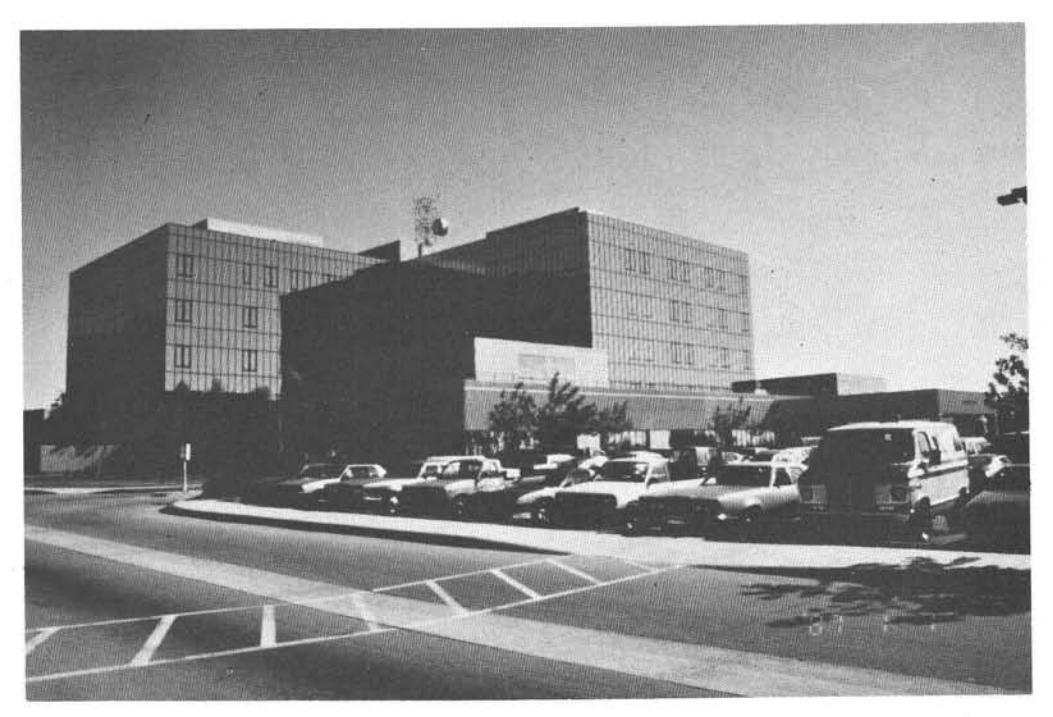
The Olive View Medical Center (identified as Sylmar Hospital) is a 6-story building plus a basement (Fig. 34). It has a central core of R/C walls and a ductile moment-resisting space steel frame. The ground and first floors have a square plan while the remainder of the building has a cruciform plan. At the end of the cross arms there are structural walls made with

Fig. 34 General view of the Olive View Medical Center.

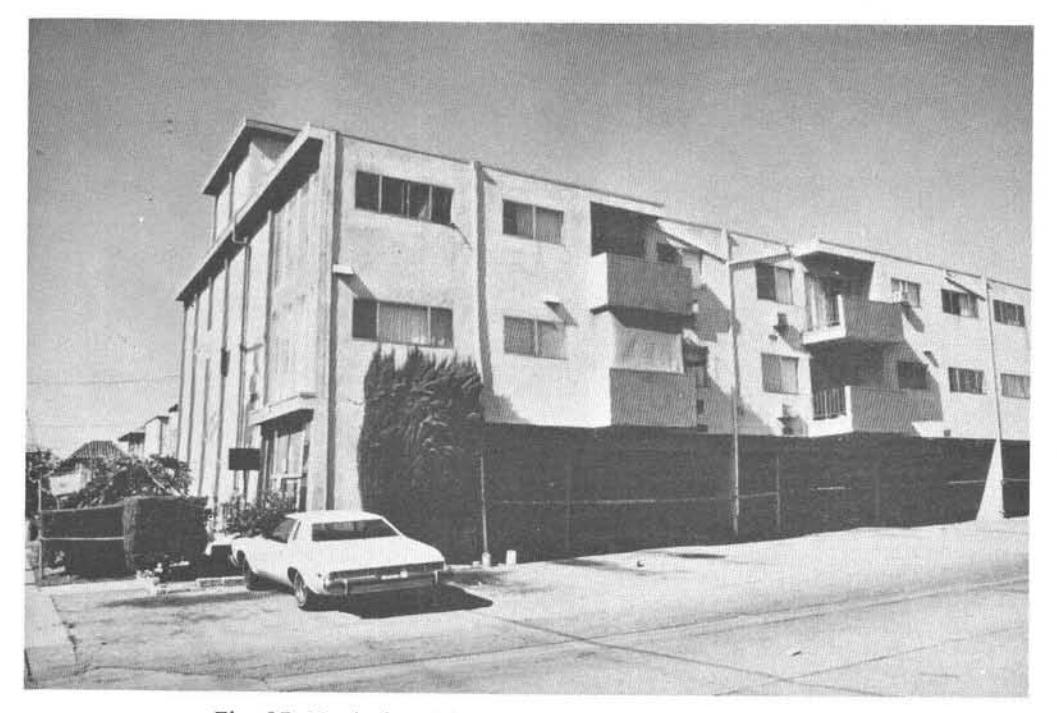
A characteristic of the damage pattern produced by the Northridge earthquake was that observed in multi-story timber frame structures. Several of them were lacking of wood structural walls. The collapse of the Northridge Meadow Apartments complex caused 16 fatalities. The structural characteristics of such type of buildings are similar: they are two- or three- story wood buildings with a ground soft story used as parking (Fig. 37). These apartment buildings were designed and constructed prior to the 1975 recommendations which required structural walls to be made with plywood sheets nailed to the frame (Fig. 38). During the earthquake, large lateral displacements were concentrated in the ground soft story (Fig. 39). In some instances, the structure was left standing but severely damaged; other buildings collapsed over the soft story. In other cases, failure was observed along the joints between the concrete masonry foundation (reinforced masonry) and the timber structure, and between upper wooden stories.

Fig. 37 Typical multi-story dwelling with first floor open spaces for parking.
